Applies To: **2008 Element 2WD** – From VIN 5J6YH1...8L013895 thru 5J6YH1...8L013924  
**2008 Element 4WD** – From VIN 5J6YH2...8L014984 thru 5J6YH2...8L015673

**August 13, 2008**

## Safety Recall: Left Rear Trailing Arm May Come Loose

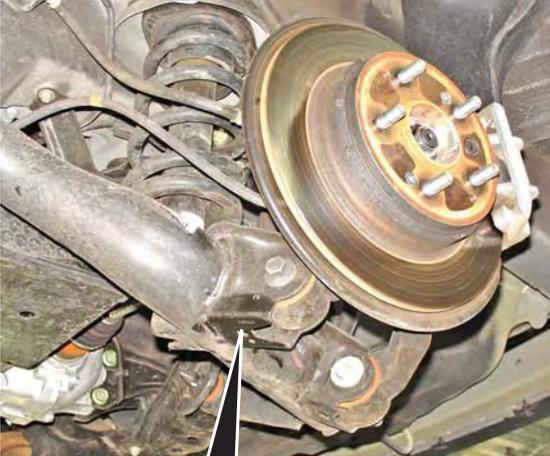
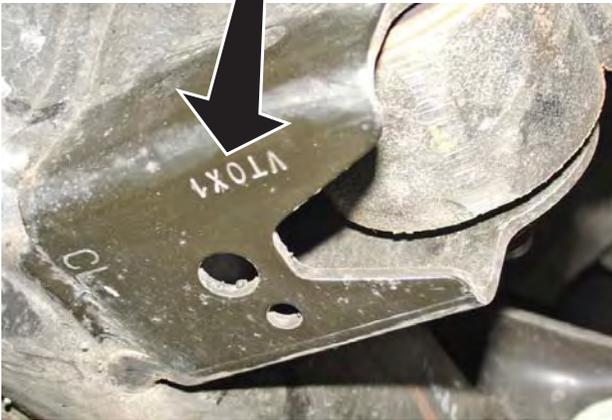
1. Raise the vehicle on a lift, and remove the left rear wheel.
2. Check the date code stamped on or near the bottom of the front lower mount of the left trailing arm:
  - If the date code is NROX 1, go to REPAIR PROCEDURE.
  - If the date code is not NROX 1, go to step 3.

3. Reinstall the left rear wheel, and torque its bolts to **108 N·m (79.6 lb-ft)**.
4. Center-punch a completion mark above the first character of the engine compartment VIN.

Center-punch here.
