## SRS Indicator Comes On With SRS DTC 3-1 or 4-1

The SRS indicator comes on, and SRS DTC 3-1 (open or increased resistance in driver's seat belt tensioner) or SRS DTC 4-1 (open or increased resistance in front passenger's seat belt tensioner) is stored.

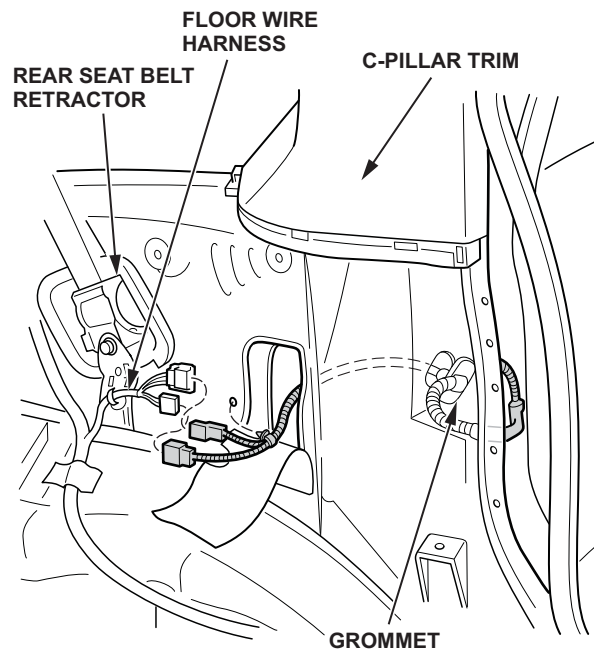
3. Disconnect the rear door subharness from the floor wire harness.

NOTE: The left rear door harness is shown; the right rear door harness is similar.

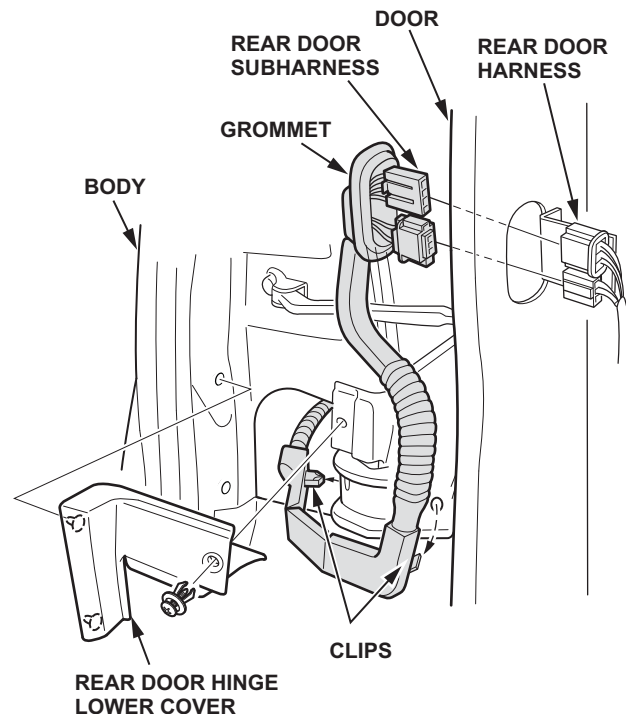
4. Remove the rear door hinge lower cover.

5. Pull out the grommet and disconnect the connectors. Remove the rear door subharness.

NOTE: The replacement harness does not have these connectors.

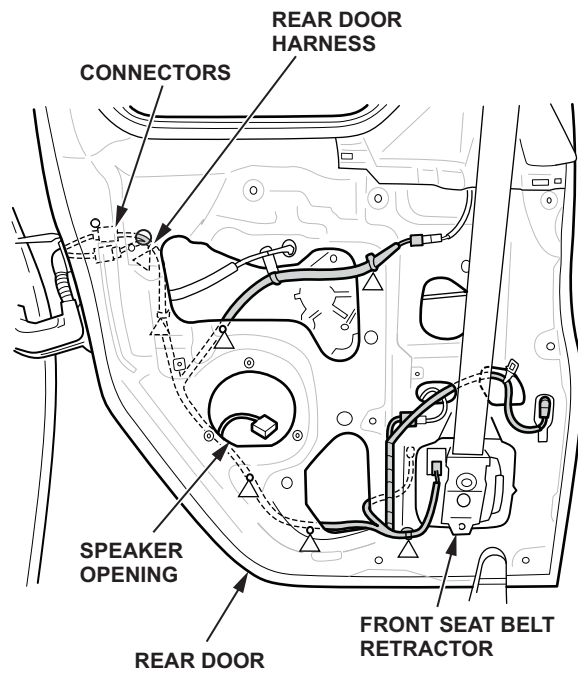
6. Remove the old harness from the door, noting all of the clip locations.

7. Install the new rear door harness, and make sure all of the connectors are securely connected. Also make sure all of the harness grommets and mounting clips are securely attached.
8. Reinstall all removed parts.
9. Turn the ignition switch to ON (II), and make sure that the SRS indicator comes on for about 6 seconds and then goes off.
