**Rattle From the A-Pillar Trim or Corners of the Dashboard**  
(Supersedes 03-056, dated September 9, 2003)

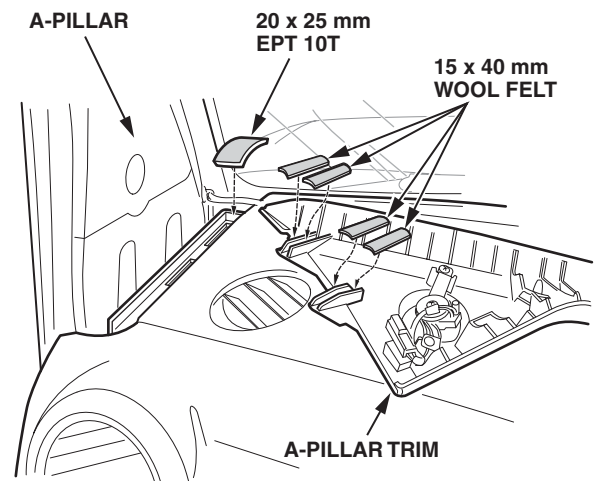
The A-pillar trim is contacting the dashboard.

1. Pull down on the A-pillar trim to release the two clips. Disconnect the tweeter connector from the trim, and remove the A-pillar trim by pulling it up (see page 20-58 of the 2003 Element Service Manual).
2. Cut a 20 x 25 mm piece of EPT 10T, and apply it to the dash panel area as shown.
