Applies To: **See VEHICLES AFFECTED**
December 14, 2005

Headlights Dim or DTC P1298 Is Stored in the ECM/PCM

(Supersedes 05-034, dated September 13, 2005, to update the information marked with the black bars)

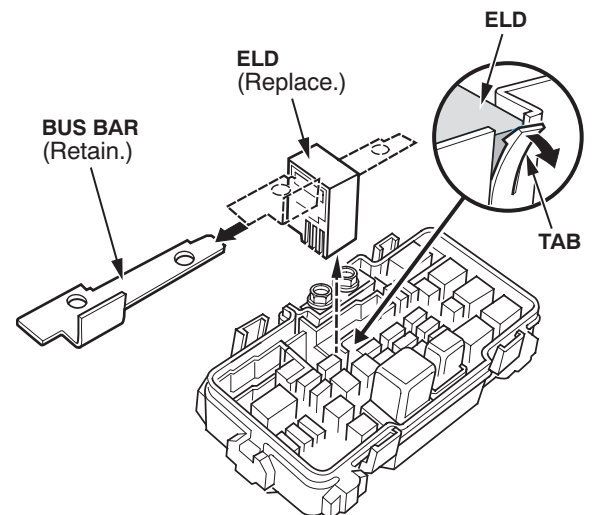
The ELD has a faulty solder joint.

8. Release the tab that holds the ELD, and pull up on the ELD to remove it.
