Applies To: **2007 Element** – ALL

**2007-08 Odyssey** – ALL

## Safety Recall: Air In VSA Modulator-Control Unit Causes Low/Soft Brake Pedal (Supersedes 10-017, dated April 13, 2010, to revise the information marked by the black bars)

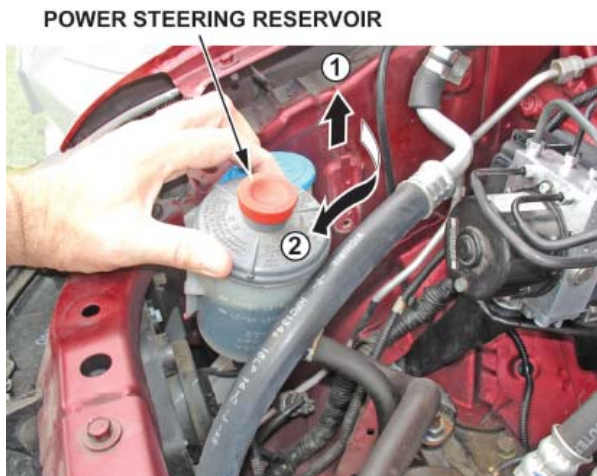
7. *Element only*: Detach the power steering reservoir from its mount on the fender, then move it out of the way.

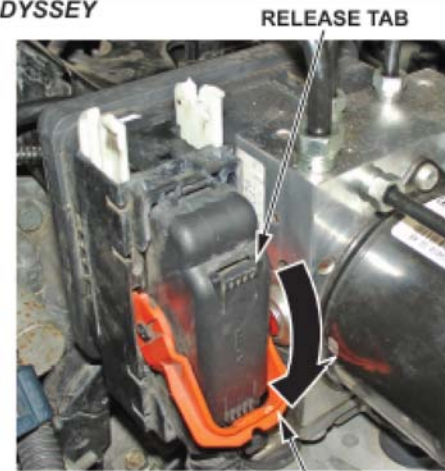
**ODYSSEY**

8. Disconnect the VSA modulator-control unit 47P connector by pressing the release tab, and then pulling down (Odyssey) or up (Element) on the orange release lever; the connector then disconnects itself.

Pull the release lever down.

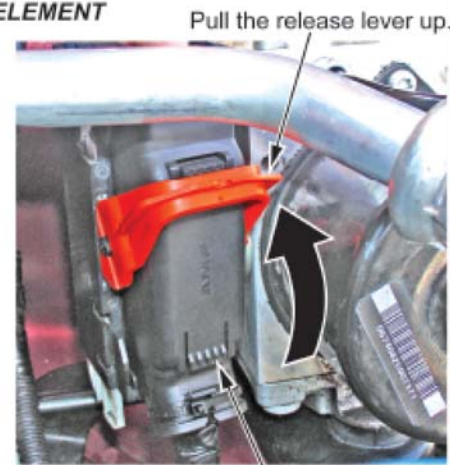
**ELEMENT**

**RELEASE TAB**

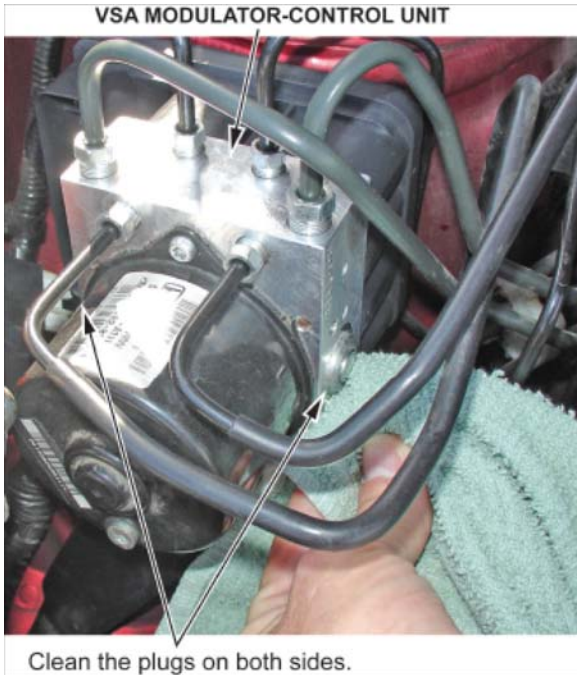
9. Moisten a clean shop towel with isopropyl alcohol, then use the towel to thoroughly clean the two plugs and the surrounding areas on the sides of the VSA modulator-control unit. Allow the alcohol to dry before you continue.

NOTE: If there is corrosion on or near the modulator plugs, remove it with a scouring pad, then thoroughly clean the area with a shop towel moistened with isopropyl alcohol. Allow the alcohol to dry before you continue.

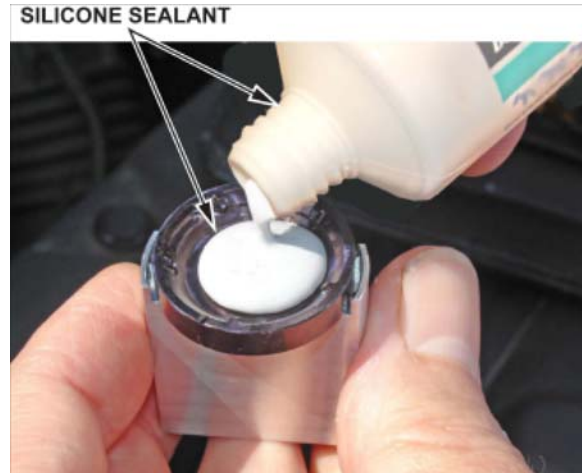
11. Fill the sealing cap half full with Dow Corning Toray SE 9186 White RTV Silicone.

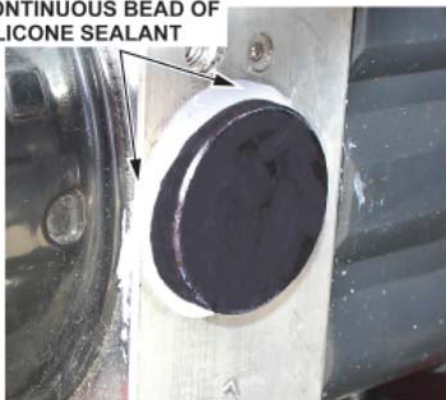
CONTINUOUS BEAD OF SILICONE SEALANT

14. Inspect the cap installation:
- The cap should fit squarely on the plug, flush to the modulator body.
  - Make sure there's a continuous bead of silicone sealant around the cap.
